Inspection Report Minerals Regulatory Program January 29, 2013

Mine Name: Beck Street Lakeview & Thomas Pit	Permit Number: M/035/0020 & M/011/0002
Operator Name: Lakeview Rock Products, Inc.	Inspection Date: January 07, 2011
Inspector(s): L Heppler	Time: 11:30 am
Other Participants: Junior - Orica	Mine Status: Active

Purpose of Inspection: Site visit was requested by Associate Director, as a result of complaints by adjacent property owners regarding blasting. These sites were last inspected as a large mine site on 04/22/2010

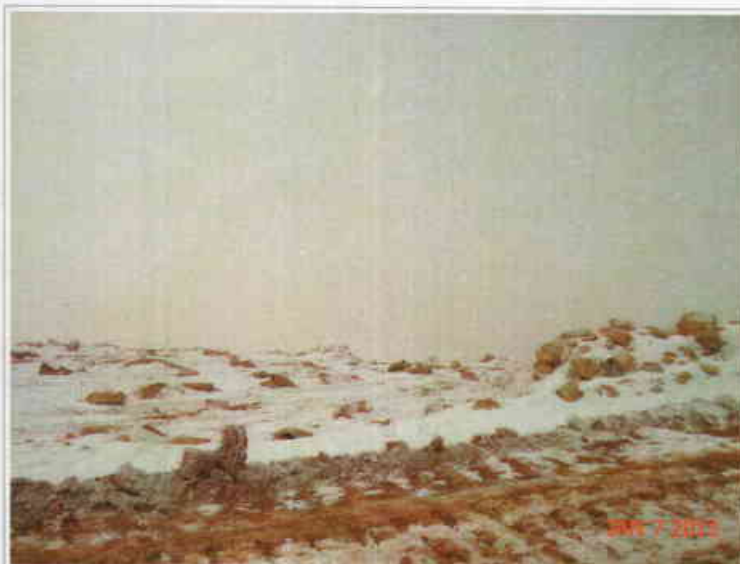
Loading of drill hole -- Bagged ANFO used

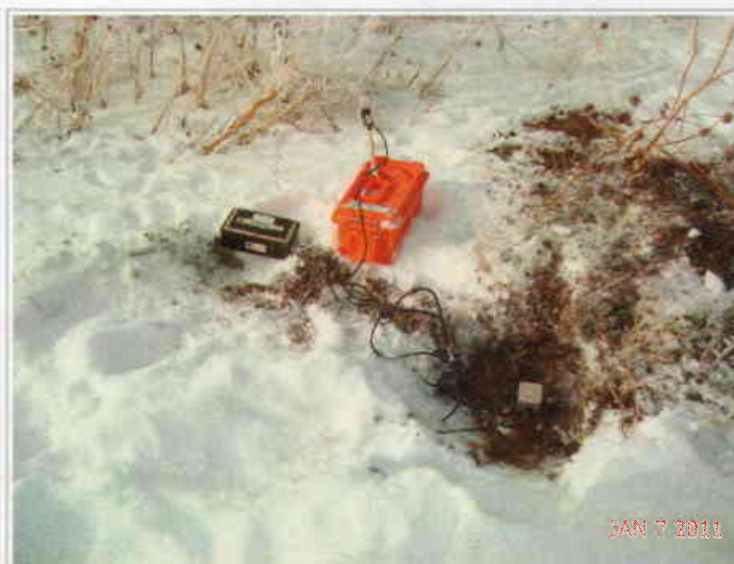
1st of 3 seismographs -- Results below national standards (2ips)

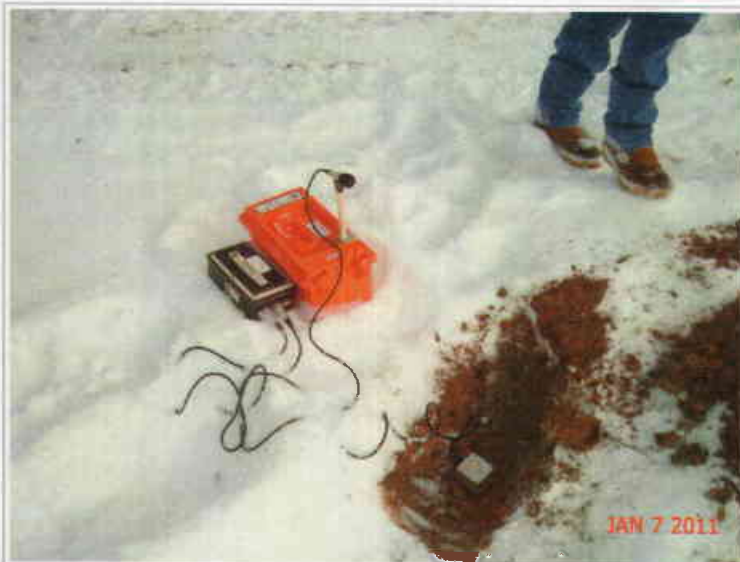
2nd of 3 seismographs - Results below national standards (2ips)

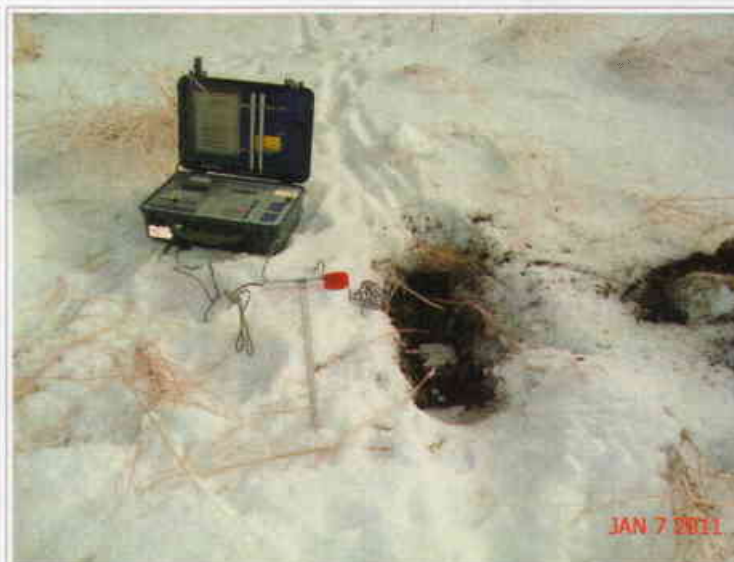
3rd of 3 seismographs - Results below national standards (2ips)
